**DEPARTMENT OF TRANSPORTATION****DIVISION OF ENGINEERING SERVICES**

Contract #: 04-0120F4Cty: SF/ALA Rte: 80 PM: 13.2/13.9File #: 1.28**WELDING INSPECTION REPORT****Resident Engineer:** Casey, William**Address:** 333 Burma Road**City:** Oakland, CA 94607**Report No:** WIR-028476**Date Inspected:** 25-Sep-2012**Project Name:** SAS Superstructure**OSM Arrival Time:** 700**Prime Contractor:** American Bridge/Fluor Enterprises, a JV**OSM Departure Time:** 1930**Contractor:** American Bridge/Fluor Enterprises, a JV**Location:** Job site**CWI Name:** N/A**CWI Present:** Yes No**Inspected CWI report:** Yes No N/A**Rod Oven in Use:** Yes No N/A**Electrode to specification:** Yes No N/A**Weld Procedures Followed:** Yes No N/A**Qualified Welders:** Yes No N/A**Verified Joint Fit-up:** Yes No N/A**Approved Drawings:** Yes No N/A**Approved WPS:** Yes No N/A**Delayed / Cancelled:** Yes No N/A**Bridge No:** 34-0006**Component:** OBG**Summary of Items Observed:**

**Ultrasonic Testing OBG**

**Lift 13E Deck drop-in splice (Weld No. DAH-13W-PP124.5-W5)**

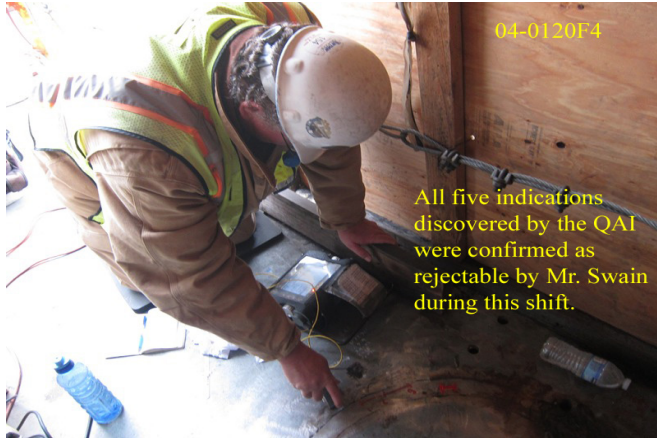
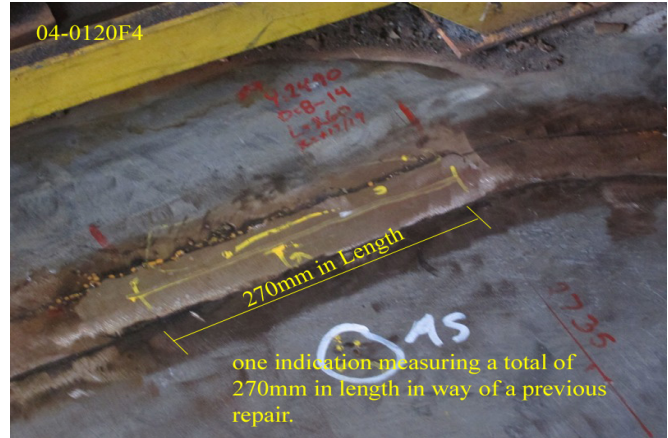
The QAI performed 60% verification of this weld from Y=0~Y=2800. A total of five (5) rejectable indications were observed at the time of inspection of which, one indication measuring a total of 270mm in length in way of a previous repair. The ABF QC inspector Patrick Swain was present for verification of the indications. The QAI observed Mr. Swain calibrate on the QAI's IIW block present onsite. All five indications discovered by the QAI were confirmed as rejectable by Mr. Swain during this shift. The ABF QC inspector Patrick Swain then stated that the weld would be re-inspected by QC due to the amount of missed indications that were present at the time of QA verification.
